Five-Year Review Report
Second Five-Year Review Report
for

Hedblum Industries Site

Au Sable Township

September 2004

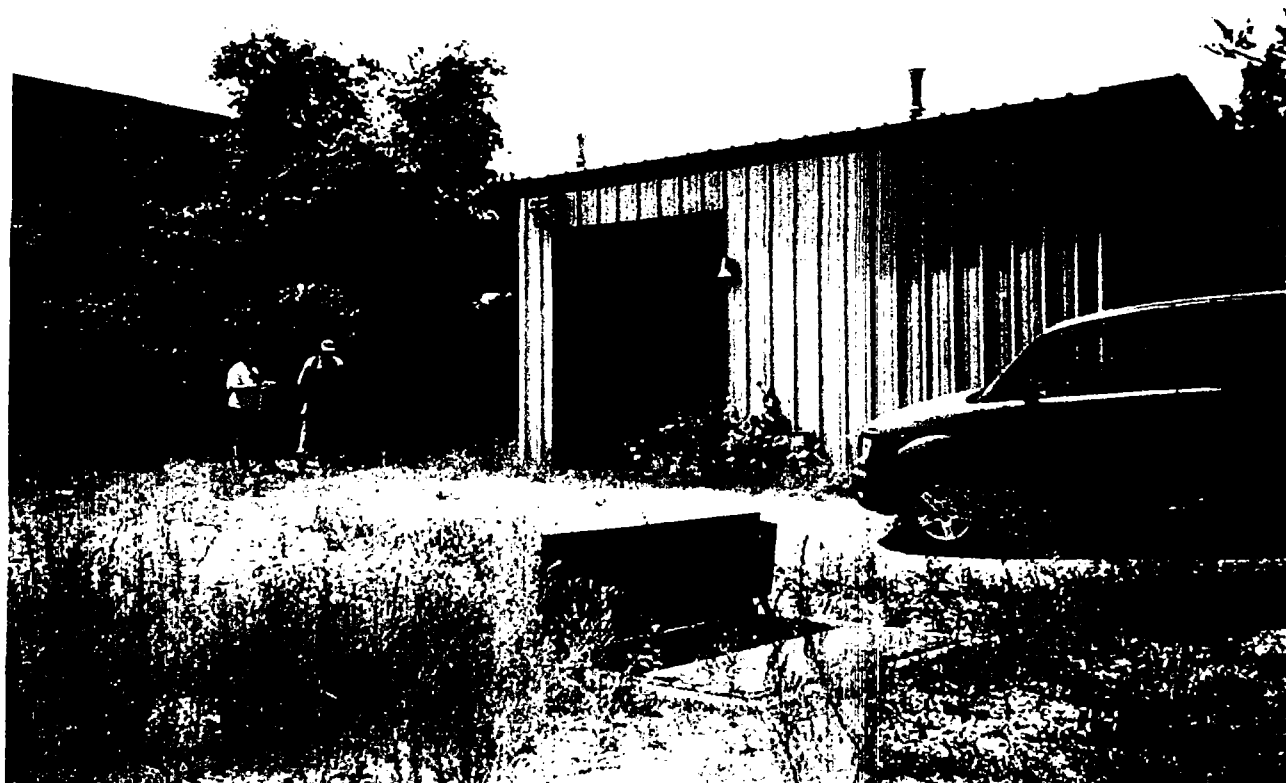
Figure 1: From East: GAC treatment plant building at north end of Aircraft Tool Supply (ATS) building. Extraction well 3 (EW -3) is in the foreground with vault door open.

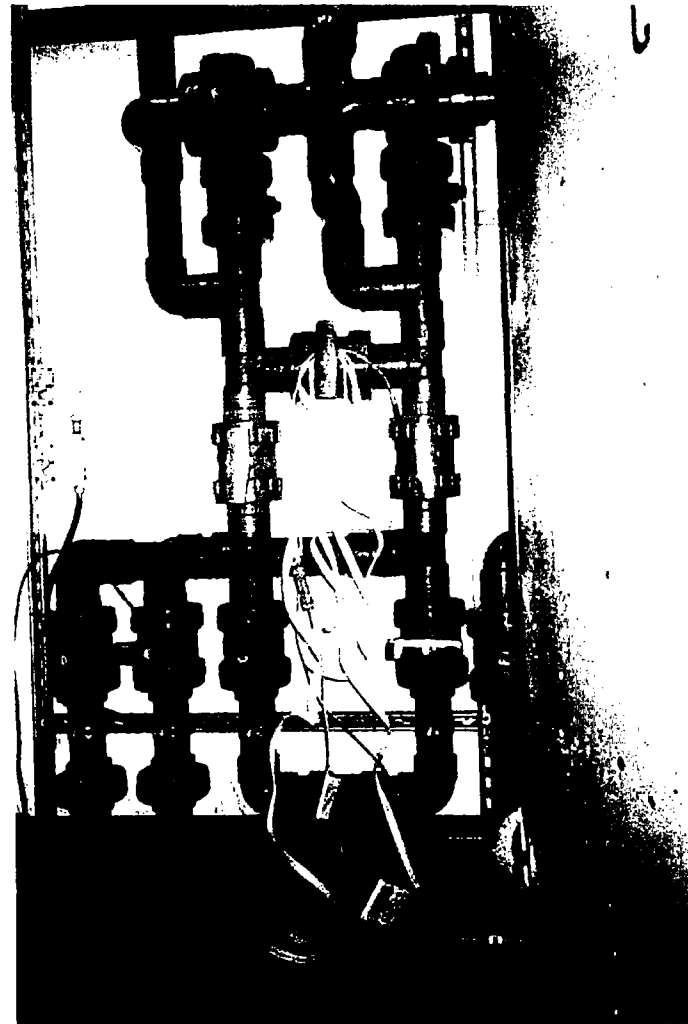
Figure 5. Flow Valves Inside the treatment building and influent/effluent piping.

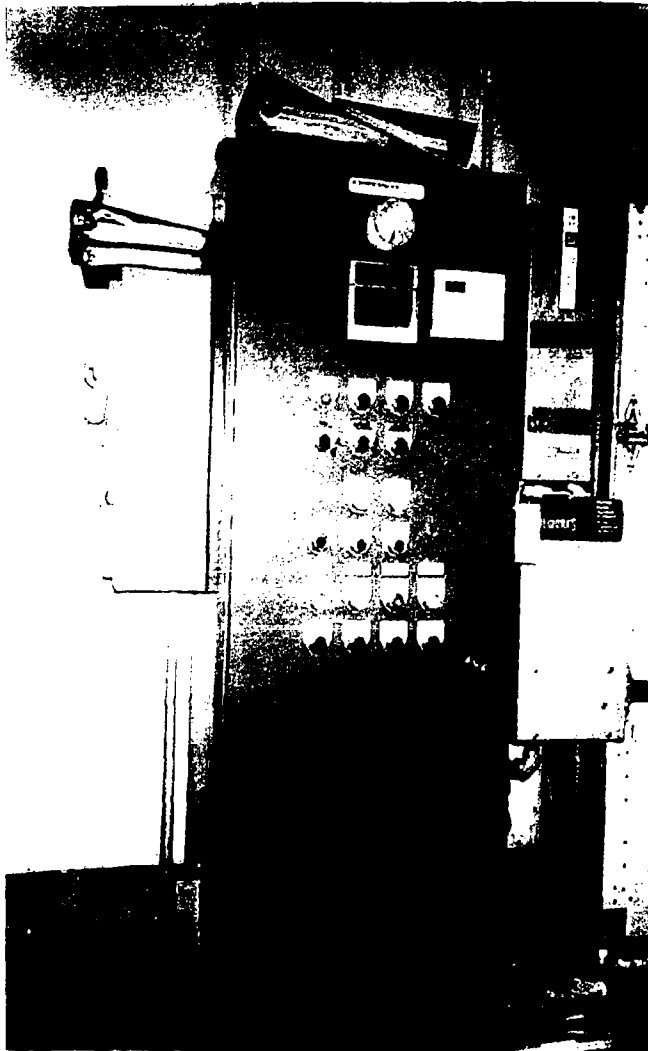
Figure 7. Inside GAC treatment building: electrical panel controlling automatic shut-down of extraction wells and annunciator system.

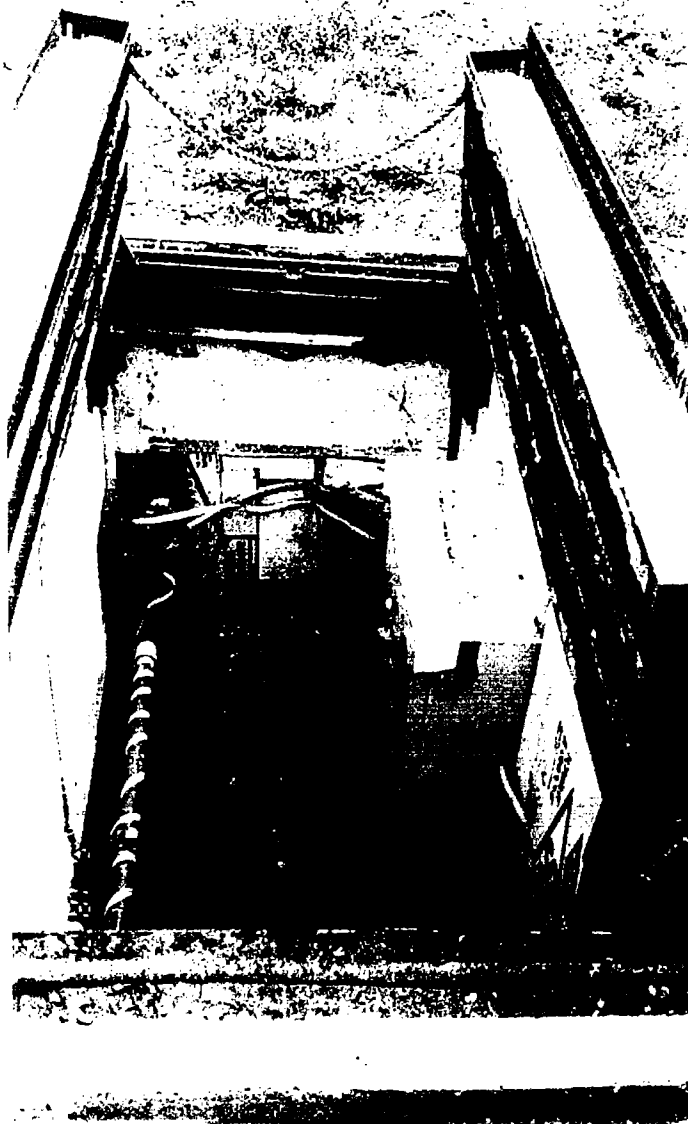
Figure 9. View inside the vault of EW-4. The 4 inch line to GAC treatment building is visible.

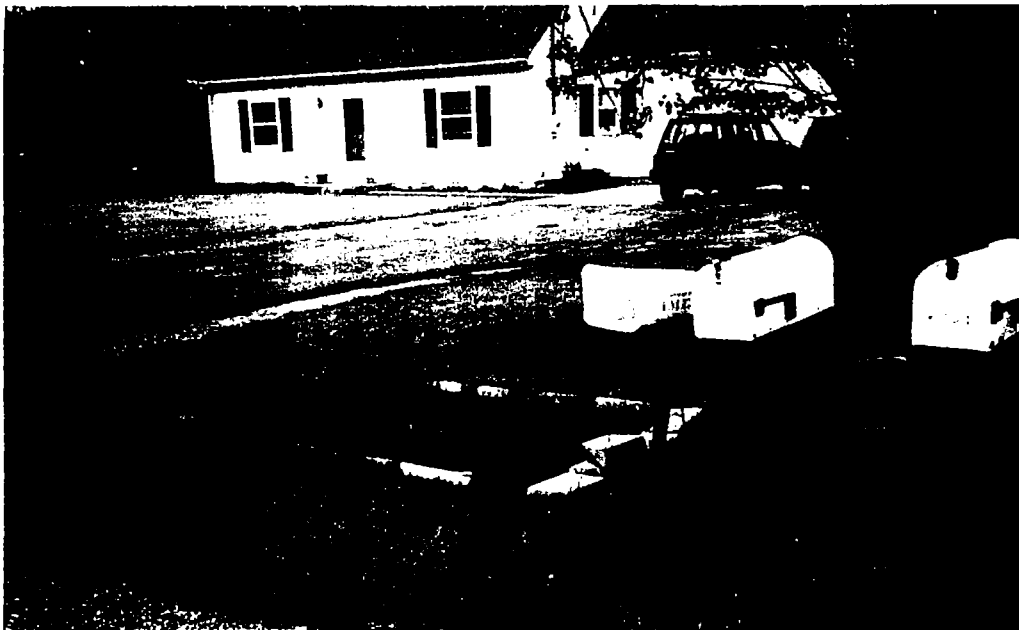
At EW-2 (the farthest downgradient well), near the bayou, the TCE concentrations have declined from 16 ppb in 1999 to nondetect in 2002. The trend increased since then to about 15 ppb in 2004 when EW-2 came back online after repairs. (See Attachment 5 for groundwater contaminant concentrations).

Figure 12. Looking North: Vault (closed) for extraction well 2 (EW-2), directly northeast of Franklin Street.

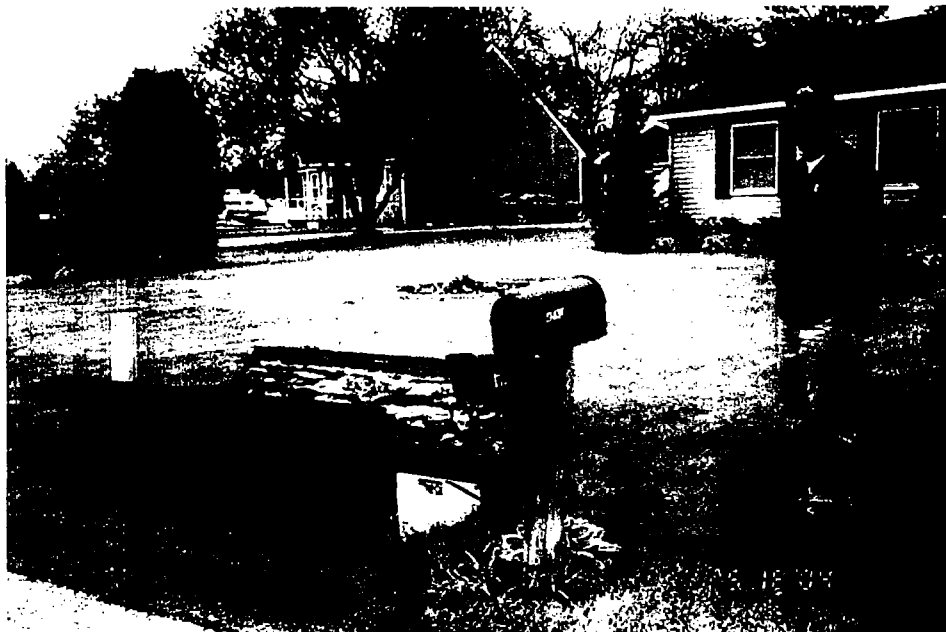
Figure 16. Looking Northwest: Extraction well EW-1 vault opened. EW-1 is located on Franklin Street.

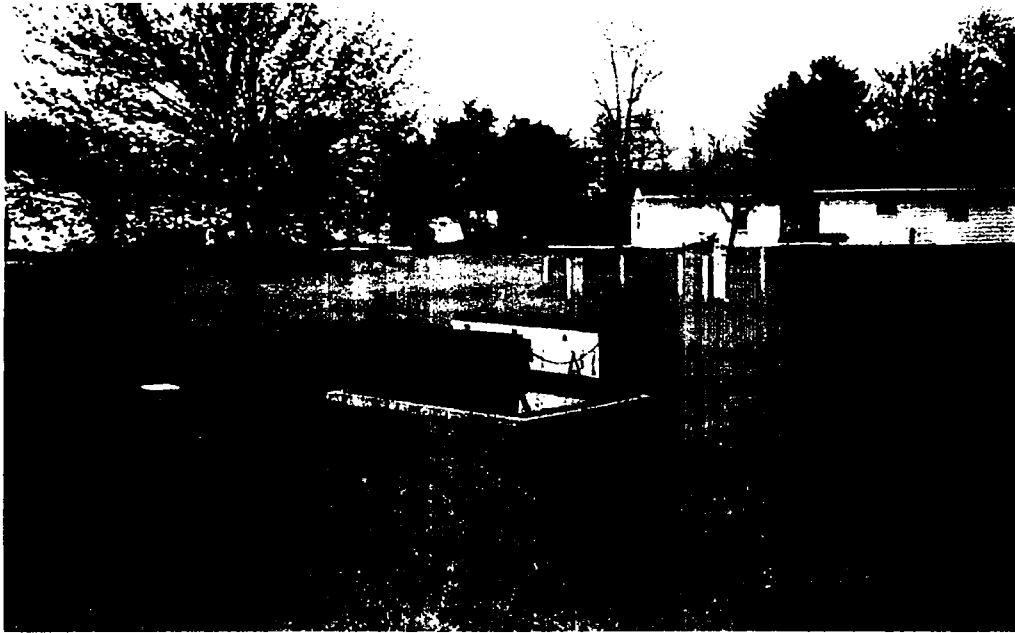
Figure 17. Looking Southwest. Extraction well EW-4 Vault (opened) in midground of photo. Monitoring wells MW-12 and MW-13 are located behind and to the right of EW-4 and are marked by the yellow stakes.
